**Flood Control Project Maintenance
Levee Inspections**

Maintenance Issue Types Only, Levee Inspection Report By Mile - Spring 2015

San Joaquin County Flood Control and Water Conservation District

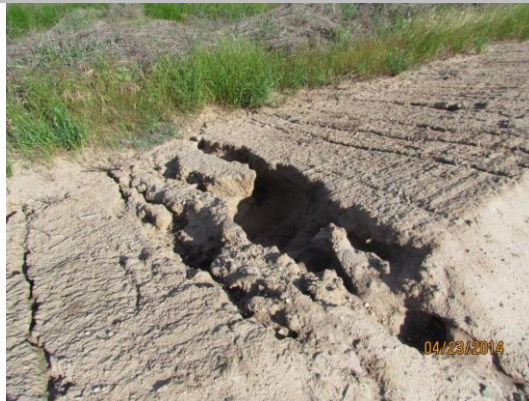
Photo 3 of 3 : SP_2015_NA0017_156_23_20150313_00016.jpg

Updated picture of the erosion on the waterside of the levee. The picture was taken during the spring 2014 inspection looking upstream.

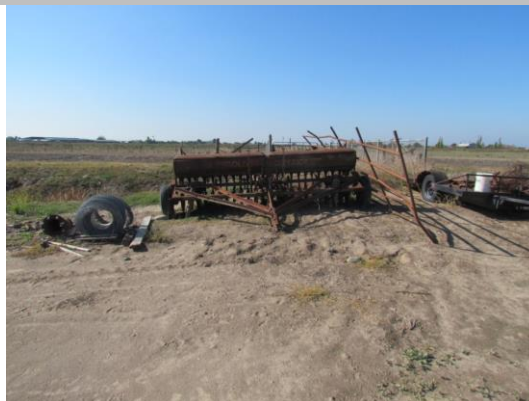
Photo 1 of 1 : SP_2015_NA0017_156_113_20150313_00024.jpg

LM Start	3.38	Rating **	M	Issue No.	113
LM End	3.38	Issue Type +	Ma	Location *	WS
Category	Earthen Levee			GPS Latitude/Longitude	
				Start	End
Item	Encroachments			38.130018 °	38.130018 °
				-121.139019 °	-121.139019 °
DWR ID	DWR_NA0017_12_s_2012_113				
Action/Comments					
Equipment

View of farming equipment that was found on the waterside of the levee looking upstream.

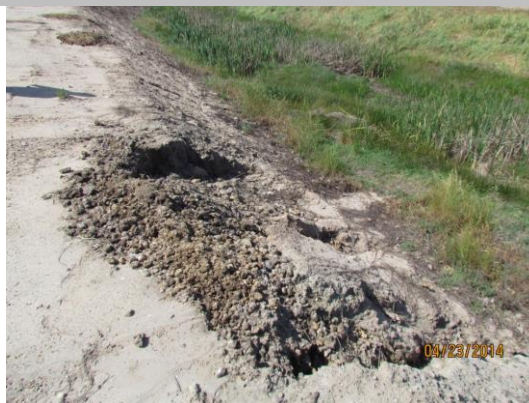
Photo 1 of 3 : SP_2015_NA0017_156_24_20150313_00018.jpg

LM Start	3.46	Rating **	M	Issue No.	24
LM End	3.46	Issue Type +	Ma	Location *	WS
Category	Earthen Levee			GPS Latitude/Longitude	
				Start	End
Item	Erosion / Bank Caving			38.131140 °	38.131140 °
				-121.138541 °	-121.138541 °
DWR ID	DWR_NA0017_12_f_2012_24				
Action/Comments					
Schedule repair of erosion site prior to the next inspection.

Updated picture of the erosion on the waterside of the levee. The picture was taken during spring 2014 inspection looking downstream.

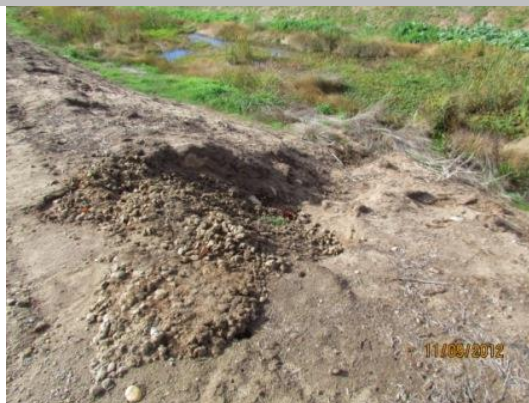
Photo 2 of 3 : SP_2015_NA0017_156_24_20150313_00019.jpg

View of erosion that was found on the waterside slope of the levee looking downstream.

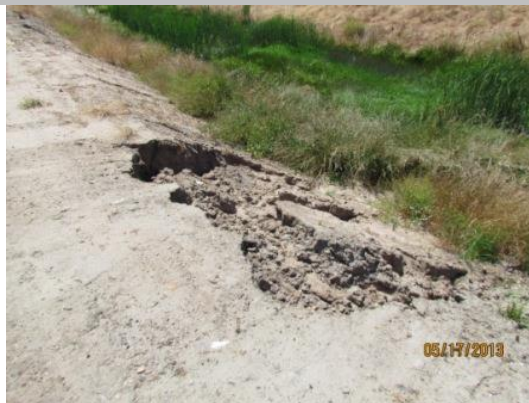
Photo 3 of 3 : SP_2015_NA0017_156_24_20150313_00020.jpg

LM Start	3.46	Rating **	M	Issue No.	24 (cont)
LM End	3.46	Issue Type +	Ma	Location *	WS
Category	Earthen Levee			GPS Latitude/Longitude	
				Start	End
Item	Erosion / Bank Caving			38.131140 °	38.131140 °
				-121.138541 °	-121.138541 °
DWR ID	DWR_NA0017_12_f_2012_24				
Action/Comments					
Schedule repair of erosion site prior to the next inspection.

Updated picture of the erosion on the waterside slope of the levee looking downstream.

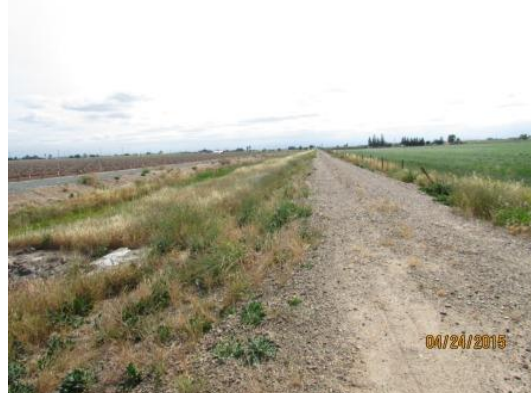
Photo 1 of 1 : SP_2015_NA0017_157_10_20150429_00006.jpg

LM Start	0.02	Rating **	M	Issue No.	10
LM End	1.24	Issue Type +	Ma	Location *	WS
Category	Earthen Levee			GPS Latitude/Longitude	
				Start	End
Item	Vegetation			38.109383 °	38.111106 °
				-121.160137 °	-121.141028 °
DWR ID	DWR_NA0017_13_s_2015_10				
Action/Comments					
Control annual grass and weeds on the levee slopes and easements.

View of vegetation along the waterside of the levee looking upstream.

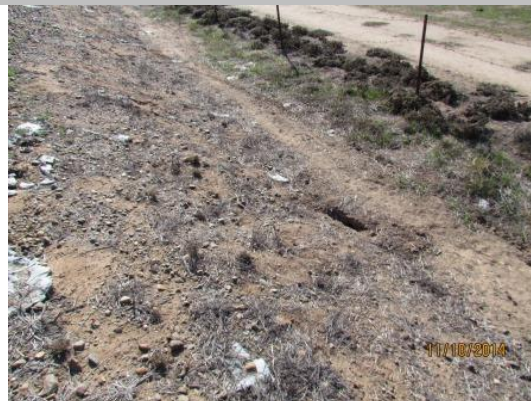
Photo 1 of 1 : SP_2015_NA0017_157_7_20150313_00004.jpg

LM Start	1.21	Rating **	M	Issue No.	7
LM End	1.21	Issue Type +	Ma	Location *	LS
Category	Earthen Levee			GPS Latitude/Longitude	
				Start	End
Item	Animal Control			38.111513 °	38.111513 °
				-121.141216 °	-121.141216 °
DWR ID	DWR_NA0017_13_f_2014_7				
Action/Comments					
No rodents visible, but rodent burrows visible; need to backfill and compact or grout burrows.

View of an animal hole that was found on the landside toe of the levee looking upstream.

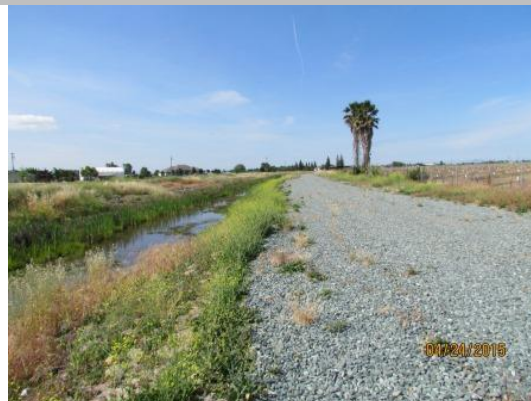
Photo 1 of 1 : SP_2015_NA0017_158_14_20150429_00012.jpg

LM Start	0.03	Rating **	M	Issue No.	14
LM End	0.54	Issue Type +	Ma	Location *	WS
Category	Earthen Levee			GPS Latitude/Longitude	
				Start	End
Item	Vegetation			38.109663 °	38.111239 °
				-121.159703 °	-121.151104 °
DWR ID	DWR_NA0017_14_s_2015_14				
Action/Comments					
Control annual grass and weeds on the levee slopes and easements.

View of vegetation along the waterside of the levee looking downstream.

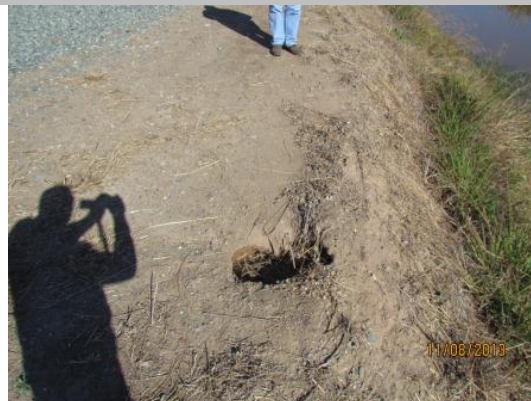
Photo 2 of 2 : SP_2015_NA0017_158_8_20150313_00010.jpg

LM Start	0.42	Rating **	M	Issue No.	8 (cont)	
LM End	0.42	Issue Type +	Ma	Location *	WS	
Category	Earthen Levee			GPS Latitude/Longitude		
				Start		End
Item	Animal Control			38.110031 °	38.110031 °	
				-121.152630 °	-121.152630 °	
DWR ID	DWR_NA0017_14_f_2013_8					
Action/Comments						
No rodents visible, but rodent burrows visible; need to backfill and compact or grout burrows.

View of a rodent hole on the waterside shoulder of the levee looking upstream.

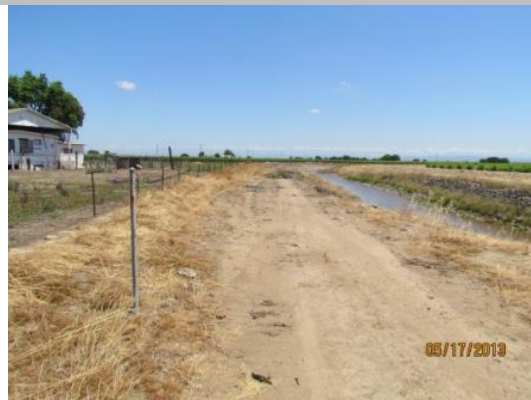
Photo 1 of 1 : SP_2015_NA0017_158_7_20150313_00008.jpg

LM Start	0.56	Rating **	M	Issue No.	7
LM End	0.56	Issue Type +	Ma	Location *	CR
Category	Earthen Levee			GPS Latitude/Longitude	
				Start	End
Item	Crown Surface / Depressions / Rutting			38.111490 °	38.111490 °
				-121.150762 °	-121.150762 °
DWR ID	DWR_NA0017_14_s_2013_7				
Action/Comments					
Repair depressions or ruts in the crown or slope.

View of a crown depression that was found looking upstream.

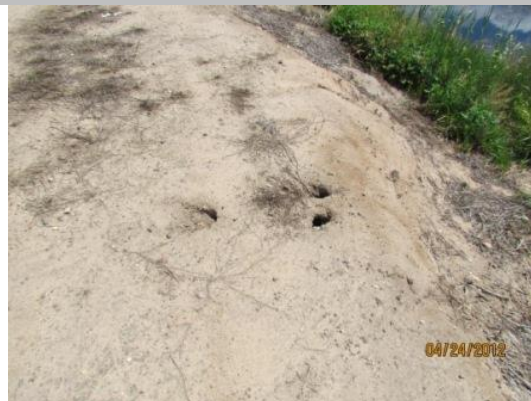
Photo 1 of 1 : SP_2015_NA0017_158_5_20150313_00006.jpg

LM Start	0.60	Rating **	M	Issue No.	5
LM End	0.60	Issue Type +	Ma	Location *	WS
Category	Earthen Levee			GPS Latitude/Longitude	
				Start	End
Item	Animal Control			38.111770 °	38.111770 °
				-121.150112 °	-121.150112 °
DWR ID	DWR_NA0017_14_s_2012_5				
Action/Comments					
No rodents visible, but rodent burrows visible; need to backfill and compact or grout burrows.

View of animal holes that were found on the waterside of the levee looking upstream.

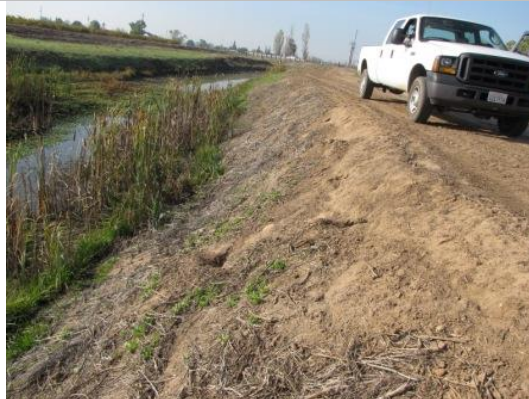
Photo 1 of 1 : SP_2015_NA0017_158_1_20150313_00001.jpg

LM Start	0.64	Rating **	M	Issue No.	1
LM End	0.64	Issue Type +	Ma	Location *	WS
Category	Earthen Levee			GPS Latitude/Longitude	
				Start	End
Item	Animal Control			38.112050 °	38.112050 °
				-121.149524 °	-121.149524 °
DWR ID	DWR_NA0017_14_s_2012_1				
Action/Comments					
Exterminate rodents and backfill and compact or grout burrows.

View of rodent holes in the waterward berm looking downstream.

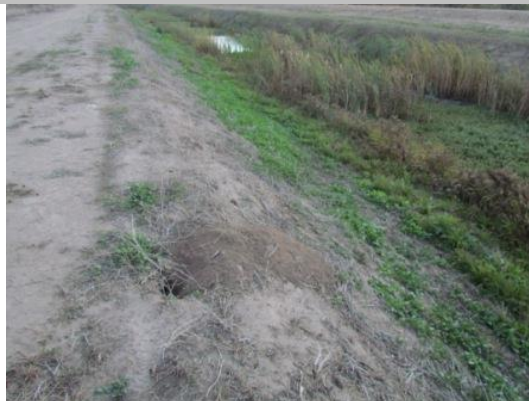
Photo 1 of 1 : SP_2015_NA0017_158_3_20150313_00003.jpg

LM Start	0.72	Rating **	M	Issue No.	3
LM End	0.72	Issue Type +	Ma	Location *	WS
Category	Earthen Levee			GPS Latitude/Longitude	
				Start	End
Item	Animal Control			38.111851 °	38.111851 °
				-121.148358 °	-121.148358 °
DWR ID	DWR_NA0017_14_s_2012_3				
Action/Comments					
No rodents visible, but rodent burrows visible; need to backfill and compact or grout burrows.

View of a rodent hole that was found on the waterside shoulder of the levee looking upstream.

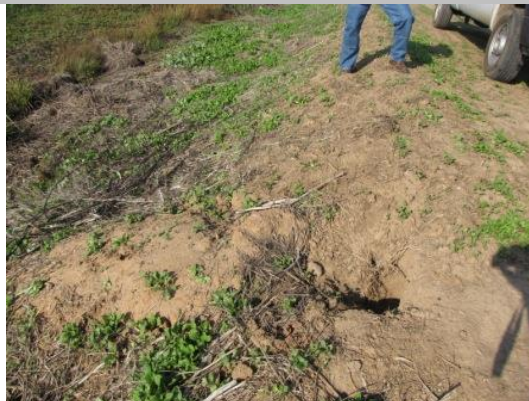
Photo 1 of 1 : SP_2015_NA0017_158_2_20150313_00002.jpg

LM Start	0.81	Rating **	M	Issue No.	2
LM End	0.81	Issue Type +	Ma	Location *	WS
Category	Earthen Levee			GPS Latitude/Longitude	
				Start	End
Item	Animal Control			38.110628 °	38.110628 °
				-121.147429 °	-121.147429 °
DWR ID	DWR_NA0017_14_s_2012_2				
Action/Comments					
Exterminate rodents and backfill and compact or grout burrows.

View of a large diameter rodent hole in the waterward berm looking downstream.

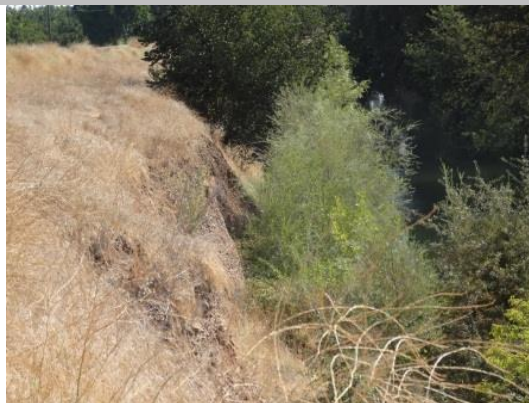
Photo 1 of 1 : SP_2015_NA0017_159_166_20150313_00096.jpg

LM Start	0.84	Rating **	M	Issue No.	166
LM End	0.84	Issue Type +	Ma	Location *	WS
Category	Supplemental			GPS Latitude/Longitude	
				Start	End
Item	DWR Erosion Survey			38.045818 °	38.045818 °
				-121.023955 °	-121.023955 °
DWR ID	DWR_NA0017_15_s_2015_166				
Action/Comments					
Inspector Comments: 8/20/2014: No significant change has been observed. 9/12/2013: No significant change observed. 08/22/2012: Site has been revisited. No significant change observed. 09/02/2011: No significant change observed on site. 11/02/2010: No significant change observed. The mile-long erosion continues to degrade the bank. There are a few trees along the mile-long stretch on the lower bank slope that are affected by the scarp. WS Levee Slope was changed to 2:1. As a result, normalized score increased from 62 to 65. 08/05/2010: Recommended for waterside repair, per CLRO; "water velocity is a major factor for accelerating bank slope erosion." 8/12/2009: Near-vertical bank erosion; degrading channel is incising the banks; recommend annual assessment and monitoring of critical erosion site, per CLRO CES Evaluation 2008 Report; district is monitoring site for change in condition; site was previously rated "U". 2007: Visited site 02/06/2007; possible critical site. [2014 Site ID:NA0017U15RM22.91]

Close view of the erosion site. Small trees grow at the lower slope of the bank.

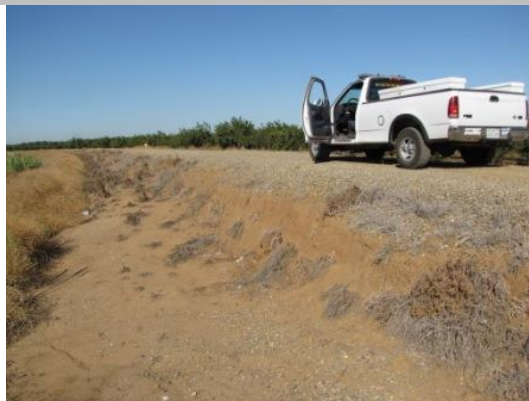
Photo 1 of 1 : SP_2015_NA0017_159_995_20150313_00113.jpg

LM Start	1.49	Rating **	M	Issue No.	995
LM End	1.49	Issue Type +	Ma	Location *	WS
Category	Earthen Levee			GPS Latitude/Longitude	
				Start	End
Item	Erosion / Bank Caving			38.040202 °	38.040202 °
				-121.032659 °	-121.032659 °
DWR ID	DWR_NA0017_15_s_2012_995				
Action/Comments					
Schedule repair of erosion site prior to the next inspection. Inspector Comments: The LMA was working on fixing the erosion site using an excavator during the inspection.

View of erosion of waterward levee slope looking upstream.

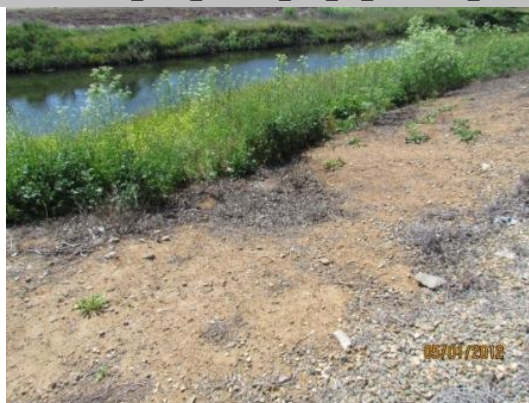
Photo 2 of 2 : SP_2015_NA0017_159_18_20150313_00010.jpg

LM Start	2.05	Rating **	M	Issue No.	18
LM End	2.05	Issue Type +	Ma	Location *	WS
Category	Earthen Levee			GPS Latitude/Longitude	
				Start	End
Item	Slope Stability			38.036294 °	38.036294 °
				-121.041089 °	-121.041089 °
DWR ID	DWR_NA0017_15_s_2012_18				
Action/Comments					
Repair slope instability.

Slope instability was found on the waterside toe of the levee looking downstream.

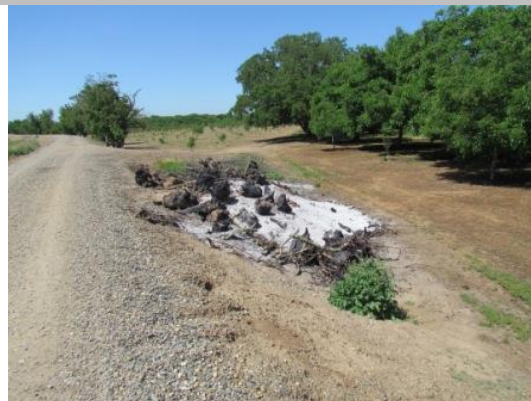
Photo 1 of 1 : SP_2015_NA0017_159_12_20150313_00006.jpg

LM Start	3.34	Rating **	M	Issue No.	12
LM End	3.34	Issue Type +	Ma	Location *	LS
Category	Earthen Levee			GPS Latitude/Longitude	
				Start	End
Item	Encroachments			38.023817 °	38.023817 °
				-121.058465 °	-121.058465 °
DWR ID	DWR_NA0017_15_s_2012_12				
Action/Comments					
Prunings					
Inspector Comments: Burn pile has been burned but new material has been placed.

New material was placed at the toe of the landside of the levee. The picture was taken from the crown looking downstream.

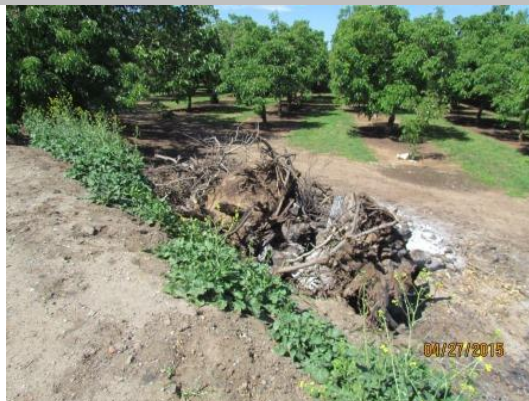
Photo 1 of 2 : SP_2015_NA0017_159_14_20150429_00132.jpg

LM Start	3.54	Rating **	A/W	Issue No.	14
LM End	3.54	Issue Type +	Ma	Location *	LS
Category	Earthen Levee			GPS Latitude/Longitude	
				Start	End
Item	Encroachments			38.021811 °	38.021811 °
				-121.061054 °	-121.061054 °
DWR ID	DWR_NA0017_15_s _ 2013_14				
Action/Comments					
Prunings					
Inspector Comments: The pit was repaired by the LMA but the prunings still exist. The burn pile is away from the levee prism.

Updated picture of the prunings on the landside toe of the levee during spring 2015 inspection.

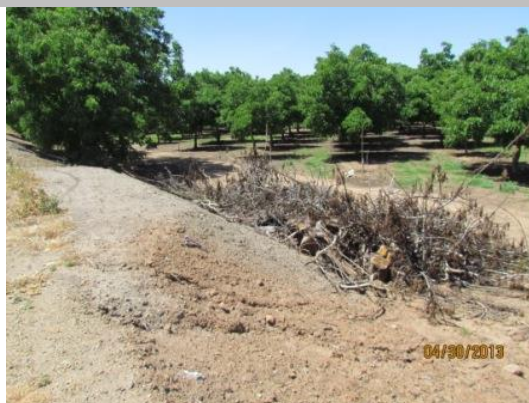
Photo 2 of 2 : SP_2015_NA0017_159_14_20150313_00007.jpg

Prunings were found on the landside toe of the levee looking downstream.

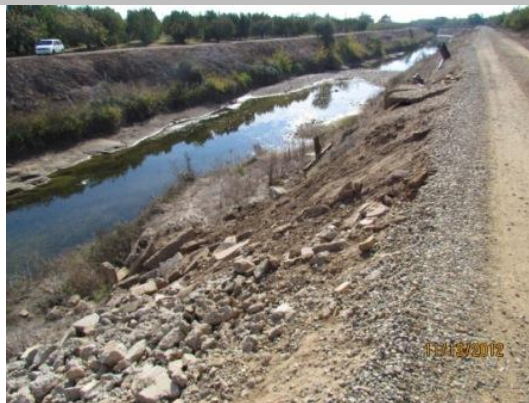
Photo 2 of 2 : SP_2015_NA0017_159_43_20150313_00029.jpg

LM Start	3.78	Rating **	M	Issue No.	43 (cont)	
LM End	3.78	Issue Type +	Ma	Location *	WS	
Category	Earthen Levee			GPS Latitude/Longitude		
				Start		End
Item	Slope Stability			38.019119 °		38.019119 °
				-121.064034 °		-121.064034 °
DWR ID	DWR_NA0017_15_f_2012_43					
Action/Comments						
Repair slope instability.

Slope instability was found on the landside slope of the levee looking downstream.

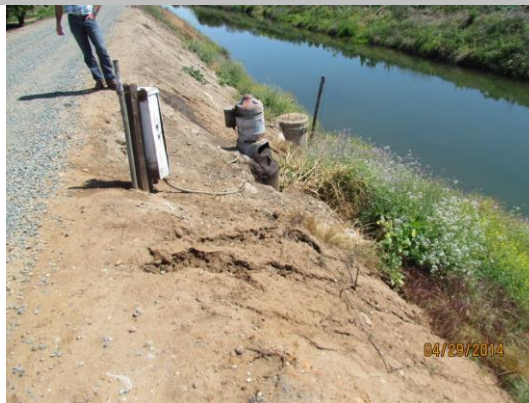
Photo 2 of 4 : SP_2015_NA0017_159_44_20150313_00031.jpg

LM Start	3.89	Rating **	M	Issue No.	44 (cont)	
LM End	3.89	Issue Type +	Ma	Location *	WS	
Category	Earthen Levee			GPS Latitude/Longitude		
				Start		End
Item	Slope Stability			38.017945 °		38.017945 °
				-121.065295 °		-121.065295 °
DWR ID	DWR_NA0017_15_f_2012_44					
Action/Comments						
Repair slope instability.

Updated picture of the slope instability on the waterside slope of the levee looking downstream during spring 2014 inspection.

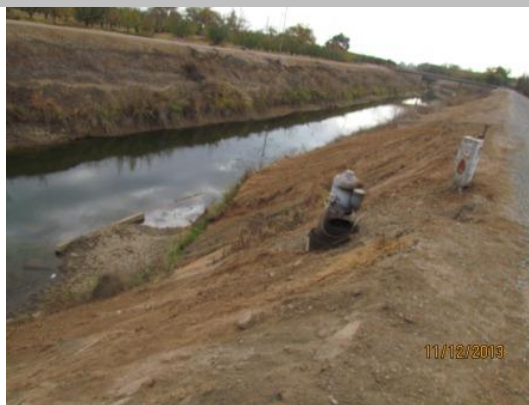
Photo 3 of 4 : SP_2015_NA0017_159_44_20150313_00032.jpg

Updated picture of the slope instability on the waterside slope of the levee looking downstream during fall 2013 inspection.

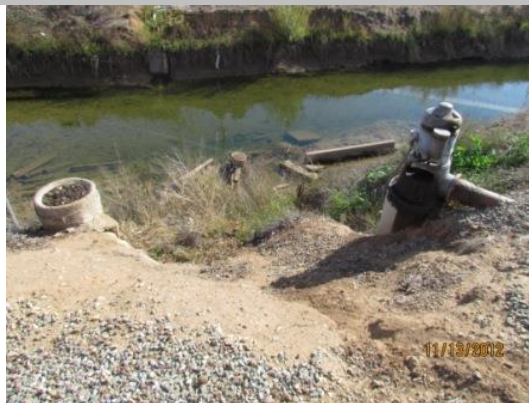
Photo 4 of 4 : SP_2015_NA0017_159_44_20150313_00034.jpg

Slope instability was found on the landside slope of the levee looking downstream.

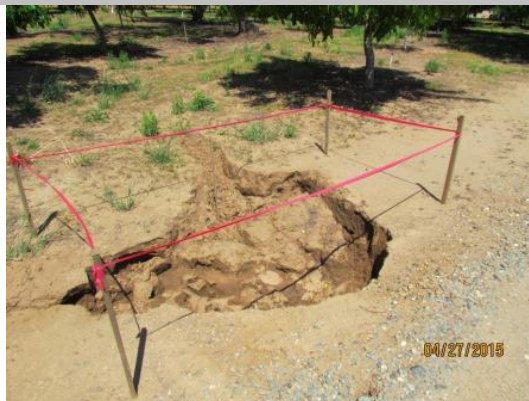
Photo 1 of 1 : SP_2015_NA0017_159_135_20150429_00134.jpg

LM Start	4.13	Rating **	U	Issue No.	135
LM End	4.13	Issue Type +	Ma	Location *	LS
Category	Earthen Levee			GPS Latitude/Longitude	
				Start	End
Item	Slope Stability			38.014957 °	38.014957 °
				-121.067512 °	-121.067512 °
DWR ID	DWR_NA0017_15_s_2015_135				
Action/Comments					
Repair slope instability. Inspector Comments: Sink hole

A sink hole was found on the landside shoulder of the levee looking upstream.

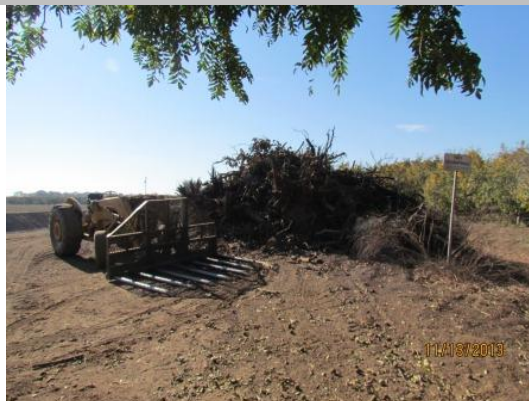
Photo 1 of 2 : SP_2015_NA0017_159_19_20150313_00011.jpg

LM Start	4.20	Rating **	M	Issue No.	19
LM End	4.20	Issue Type +	Ma	Location *	LS
Category	Earthen Levee			GPS Latitude/Longitude	
				Start	End
Item	Encroachments			38.014025 °	38.014025 °
				-121.067983 °	-121.067983 °
DWR ID	DWR_NA0017_15_s_2012_19				
Action/Comments					
Prunings Inspector Comments: Burn pile has been burned but new material has been placed.

Updated picture of the prunings pile on the landside of the levee looking downstream during fall 2013 inspection.

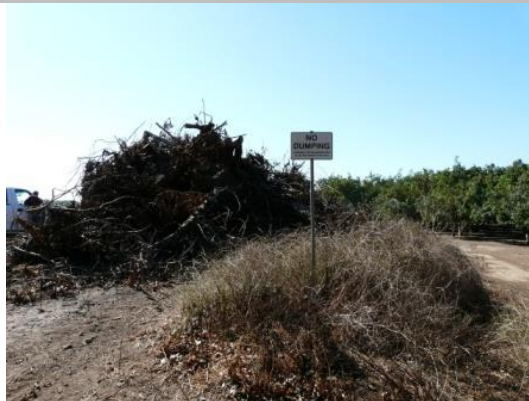
Photo 2 of 2 : SP_2015_NA0017_159_19_20150313_00012.jpg

LM Start	4.20	Rating **	M	Issue No.	19 (cont)	
LM End	4.20	Issue Type +	Ma	Location *	LS	
Category	Earthen Levee			GPS Latitude/Longitude		
				Start		End
Item	Encroachments			38.014025 °		38.014025 °
				-121.067983 °		-121.067983 °
DWR ID	DWR_NA0017_15_s_2012_19					
Action/Comments						
Prunings						
Inspector Comments: Burn pile has been burned but new material has been placed.

Example of a prunings pile immediately adjacent to access road.
Evidence of habitual burnings at this site.

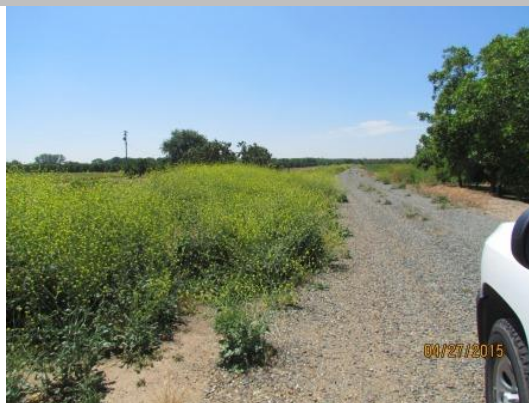
Photo 1 of 1 : SP_2015_NA0017_159_139_20150429_00135.jpg

LM Start	4.22	Rating **	M	Issue No.	139
LM End	5.16	Issue Type +	Ma	Location *	WS
Category	Earthen Levee			GPS Latitude/Longitude	
				Start	End
Item	Vegetation			38.013825 °	38.001545 °
				-121.068198 °	-121.074999 °
DWR ID	DWR_NA0017_15_s_2015_139				
Action/Comments					
Control annual grass and weeds on the levee slopes and easements.

View of vegetation along the waterside of the levee looking downstream.

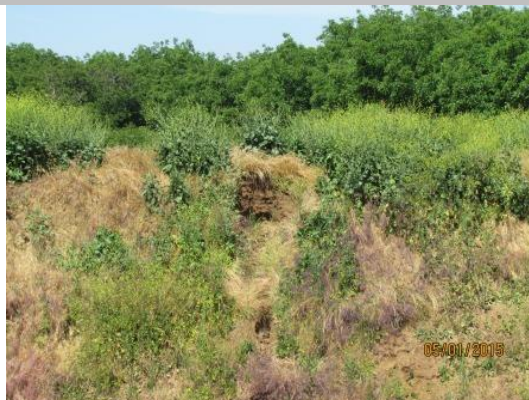
Photo 1 of 1 : SP_2015_NA0017_159_209_20150501_00149.jpg

LM Start	4.31	Rating **	M	Issue No.	209
LM End	4.31	Issue Type +	Ma	Location *	WS
Category	Earthen Levee			GPS Latitude/Longitude	
				Start	End
Item	Animal Control			38.012474 °	38.012474 °
				-121.068144 °	-121.068144 °
DWR ID	DWR_NA0017_15_s_2015_209				
Action/Comments					
No rodents visible, but rodent burrows visible; need to backfill and compact or grout burrows.

A large rodent hole was found on the waterside of the levee. The picture was taken across the levee.

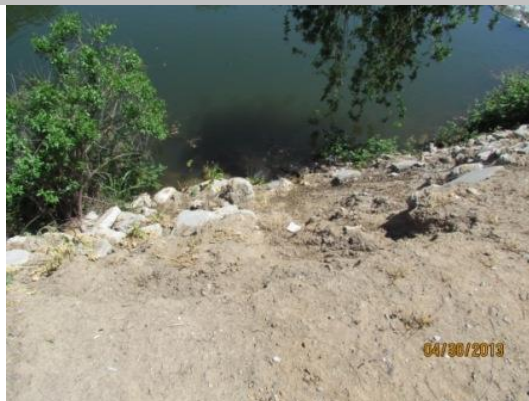
Photo 1 of 3 : SP_2015_NA0017_159_96_20150313_00066.jpg

LM Start	4.63	Rating **	M	Issue No.	96
LM End	4.63	Issue Type +	Ma	Location *	WS
Category	Earthen Levee			GPS Latitude/Longitude	
				Start	End
Item	Erosion / Bank Caving			38.008053 °	38.008053 °
				-121.070141 °	-121.070141 °
DWR ID	DWR_NA0017_15_s_2012_96				
Action/Comments					
Note and monitor erosion site. Inspector Comments: LMA has fixed the issue but the riprap has rebar which would can be dangerous during the flood fighting efforts.

Updated picture of the slope instability on the waterside slope of the levee looking downstream during spring 2013 inspection.

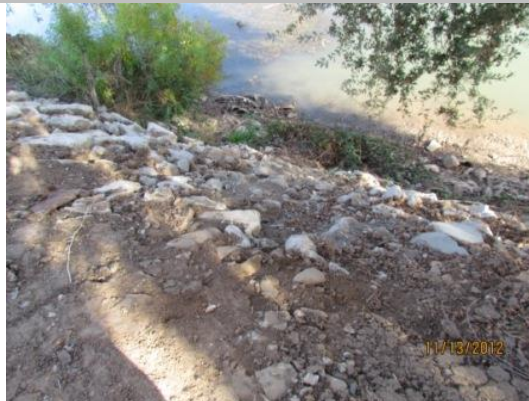
Photo 2 of 3 : SP_2015_NA0017_159_96_20150313_00067.jpg

LM Start	4.63	Rating **	M	Issue No.	96 (cont)
LM End	4.63	Issue Type +	Ma	Location *	WS
Category	Earthen Levee			GPS Latitude/Longitude	
				Start	End
Item	Erosion / Bank Caving			38.008053 °	38.008053 °
				-121.070141 °	-121.070141 °
DWR ID	DWR_NA0017_15_s _ 2012_96				
Action/Comments					
Note and monitor erosion site. Inspector Comments: LMA has fixed the issue but the riprap has rebar which would can be dangerous during the flood fighting efforts.

The LMA has fixed the erosion on the landside slope of the levee but the riprap contains exposed rebar which could be dangerous during a flood fight.

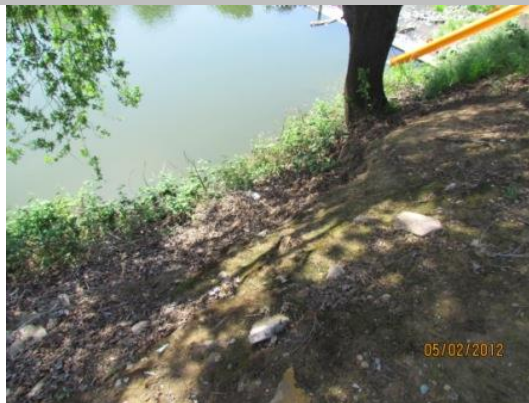
Photo 3 of 3 : SP_2015_NA0017_159_96_20150313_00068.jpg

Erosion was found on the waterside slope of the levee looking downstream.

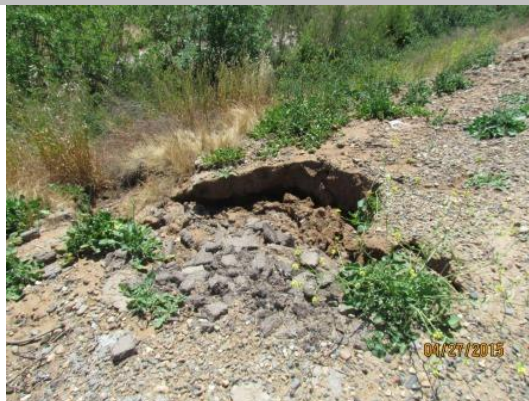
Photo 1 of 2 : SP_2015_NA0017_159_171_20150429_00136.jpg

LM Start	5.03	Rating **	M	Issue No.	171
LM End	5.03	Issue Type +	Ma	Location *	WS
Category	Earthen Levee			GPS Latitude/Longitude	
				Start	End
Item	Slope Stability			38.003105 °	38.003105 °
				-121.073585 °	-121.073585 °
DWR ID	DWR_NA0017_15_f_2014_171				
Action/Comments					
Repair slope instability.

Updated picture of the slope instability on the waterside of the levee looking downstream during spring 2015 inspection.

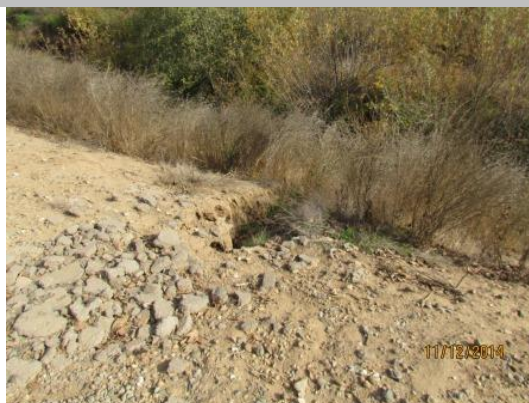
Photo 2 of 2 : SP_2015_NA0017_159_171_20150313_00097.jpg

A slope instability was found on the waterside of the levee looking upstream.

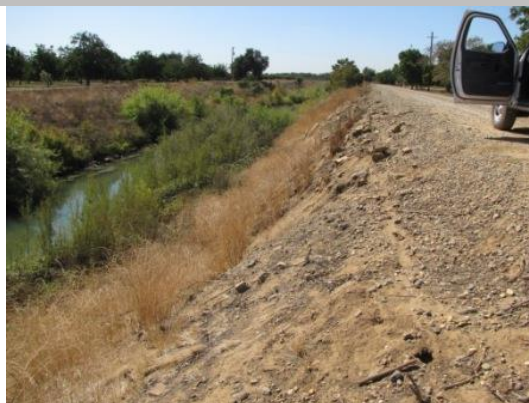
Photo 1 of 1 : SP_2015_NA0017_159_1009_20150313_00114.jpg

LM Start	5.04	Rating **	M	Issue No.	1009
LM End	5.04	Issue Type +	Ma	Location *	WS
Category	Earthen Levee			GPS Latitude/Longitude	
				Start	End
Item	Slope Stability			38.003021 °	38.003021 °
				-121.073658 °	-121.073658 °
DWR ID	DWR_NA0017_15_s_2012_1009				
Action/Comments					
Repair slope instability.

View of a slip in the waterward levee slope looking downstream.

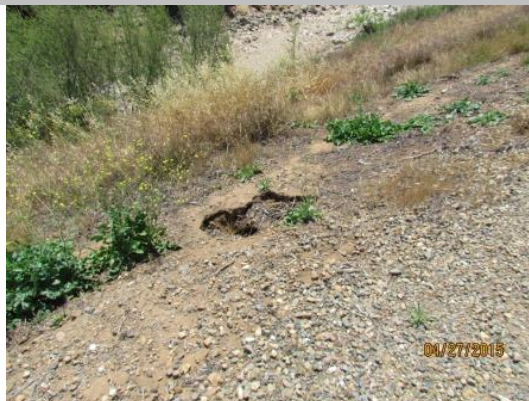
Photo 1 of 1 : SP_2015_NA0017_159_143_20150429_00137.jpg

LM Start	5.06	Rating **	M	Issue No.	143
LM End	5.06	Issue Type +	Ma	Location *	WS
Category	Earthen Levee			GPS Latitude/Longitude	
				Start	End
Item	Animal Control			38.002715 °	38.002715 °
				-121.073960 °	-121.073960 °
DWR ID	DWR_NA0017_15_s_2015_143				
Action/Comments					
No rodents visible, but rodent burrows visible; need to backfill and compact or grout burrows.

Rodent holes were found on the waterside slope of the levee looking downstream.

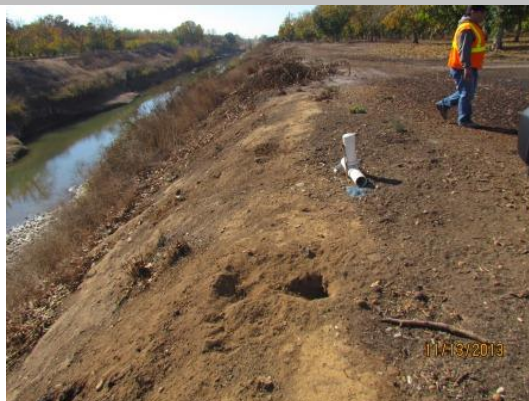
Photo 1 of 2 : SP_2015_NA0017_159_30_20150313_00019.jpg

LM Start	5.66	Rating **	M	Issue No.	30
LM End	5.66	Issue Type +	Ma	Location *	WS
Category	Earthen Levee			GPS Latitude/Longitude	
				Start	End
Item	Animal Control			37.995679 °	37.995679 °
				-121.080267 °	-121.080267 °
DWR ID	DWR_NA0017_15_s_2013_30				
Action/Comments					
No rodents visible, but rodent burrows visible; need to backfill and compact or grout burrows.

Updated picture of the animal holes on the waterside of the levee looking downstream.

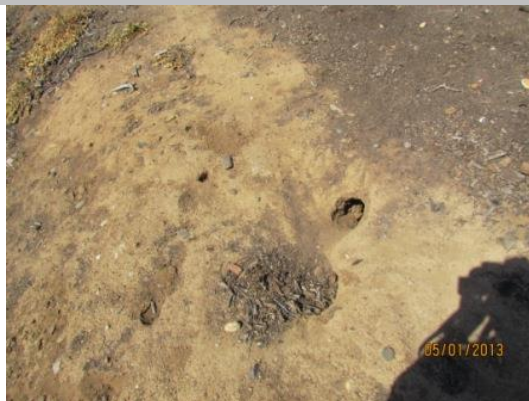
Photo 2 of 2 : SP_2015_NA0017_159_30_20150313_00020.jpg

LM Start	5.66	Rating **	M	Issue No.	30 (cont)
LM End	5.66	Issue Type +	Ma	Location *	WS
Category	Earthen Levee			GPS Latitude/Longitude	
				Start	End
Item	Animal Control			37.995679 °	37.995679 °
				-121.080267 °	-121.080267 °
DWR ID	DWR_NA0017_15_s_2013_30				
Action/Comments					
No rodents visible, but rodent burrows visible; need to backfill and compact or grout burrows.

Animal holes were found on the waterside slope of the levee looking downstream.

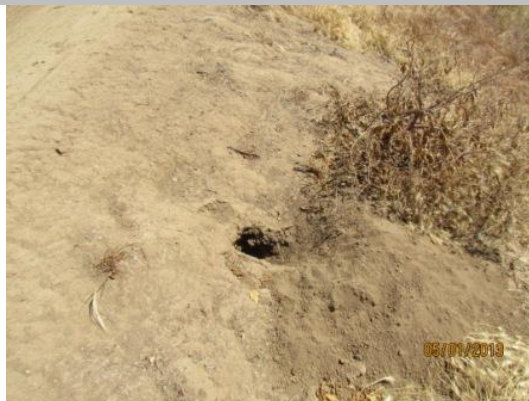
Photo 1 of 1 : SP_2015_NA0017_159_41_20150313_00027.jpg

LM Start	6.00	Rating **	M	Issue No.	41
LM End	6.00	Issue Type +	Ma	Location *	WS
Category	Earthen Levee			GPS Latitude/Longitude	
				Start	End
Item	Animal Control			37.991648 °	37.991648 °
				-121.083924 °	-121.083924 °
DWR ID	DWR_NA0017_15_s_2013_41				
Action/Comments					
No rodents visible, but rodent burrows visible; need to backfill and compact or grout burrows.

An animal hole was found on the waterside slope of the levee looking upstream.

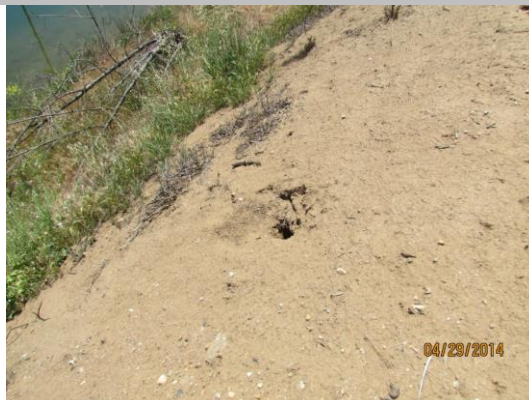
Photo 1 of 1 : SP_2015_NA0017_159_75_20150313_00055.jpg

LM Start	6.17	Rating **	M	Issue No.	75
LM End	6.17	Issue Type +	Ma	Location *	WS
Category	Earthen Levee			GPS Latitude/Longitude	
				Start	End
Item	Animal Control			37.989630 °	37.989630 °
				-121.085754 °	-121.085754 °
DWR ID	DWR_NA0017_15_s_2014_75				
Action/Comments					
No rodents visible, but rodent burrows visible; need to backfill and compact or grout burrows.

A rodent hole was found on the waterside shoulder of the levee looking downstream.

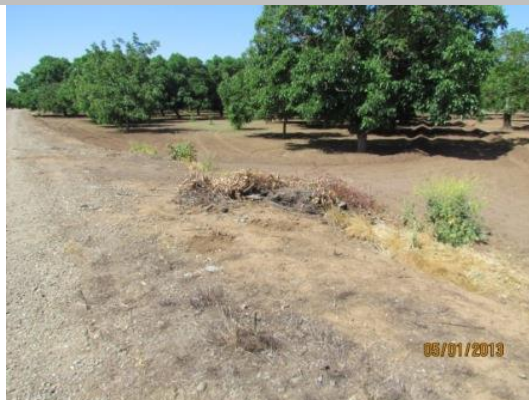
Photo 1 of 1 : SP_2015_NA0017_159_98_20150313_00069.jpg

LM Start	6.46	Rating **	M	Issue No.	98
LM End	6.46	Issue Type +	Ma	Location *	LS
Category	Earthen Levee			GPS Latitude/Longitude	
				Start	End
Item	Encroachments			37.986225 °	37.986225 °
				-121.088704 °	-121.088704 °
DWR ID	DWR_NA0017_15_f_2012_98				
Action/Comments					
Prunings

Prunings were found on the landside of the levee looking downstream.

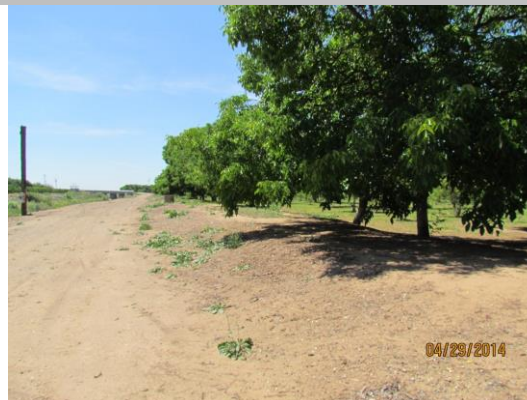
Photo 1 of 1 : SP_2015_NA0017_159_115_20150313_00078.jpg

LM Start	6.96	Rating **	M	Issue No.	115
LM End	7.20	Issue Type +	Ma	Location *	LS
Category	Earthen Levee			GPS Latitude/Longitude	
				Start	End
Item	Trim / Thin Trees			37.981387 °	37.979749 °
				-121.095370 °	-121.099178 °
DWR ID	DWR_NA0017_15_s_2014_115				
Action/Comments					
Trim trees to at least five feet above ground level.

Tree limbs were obstructing the visibility of the crown of the levee looking downstream.

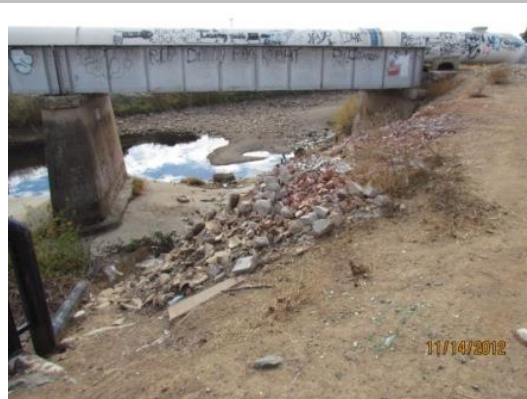
Photo 1 of 1 : SP_2015_NA0017_159_102_20150313_00070.jpg

LM Start	7.21	Rating **	M	Issue No.	102
LM End	7.21	Issue Type +	Ma	Location *	WS
Category	Earthen Levee			GPS Latitude/Longitude	
				Start	End
Item	Encroachments			37.979612 °	37.979612 °
				-121.099390 °	-121.099390 °
DWR ID	DWR_NA0017_15_s_2012_102				
Action/Comments					
Debris

Debris was found on the waterside slope of the levee looking downstream.

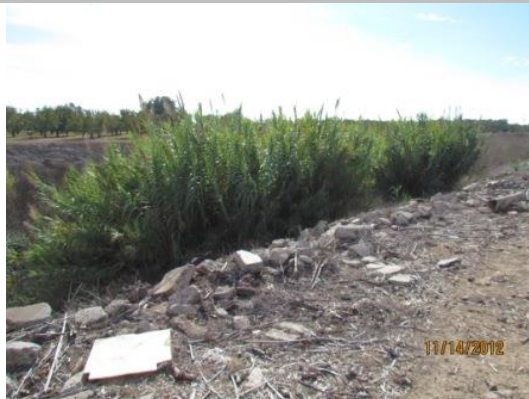
Photo 1 of 2 : SP_2015_NA0017_159_104_20150313_00071.jpg

LM Start	7.89	Rating **	M	Issue No.	104
LM End	7.89	Issue Type +	Ma	Location *	WS
Category	Earthen Levee			GPS Latitude/Longitude	
				Start	End
Item	Vegetation			37.974304 °	37.974304 °
				-121.109625 °	-121.109625 °
DWR ID	DWR_NA0017_15_s _ 2012_104				
Action/Comments					
Remove the wild growth other than native grasses from the levee slopes.

Updated picture of the Arundo on the waterside slope of the levee looking downstream.

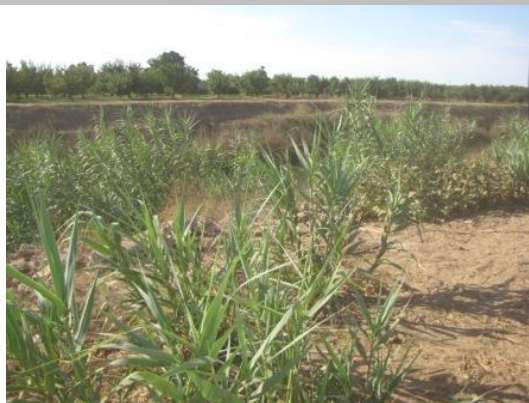
Photo 2 of 2 : SP_2015_NA0017_159_104_20150313_00072.jpg

View of arrundo on the waterward shoulder and slope blocking visibility looking downstream.

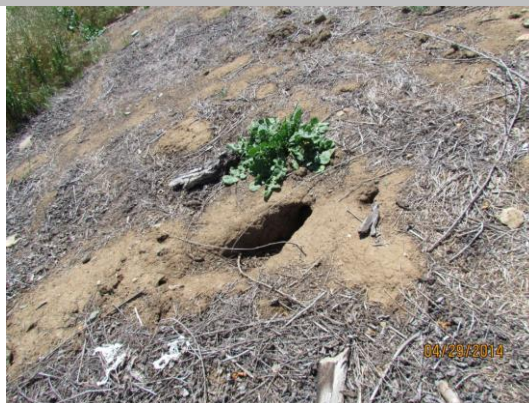
Photo 1 of 1 : SP_2015_NA0017_159_122_20150313_00082.jpg

LM Start	8.11	Rating **	M	Issue No.	122
LM End	8.11	Issue Type +	Ma	Location *	WS
Category	Earthen Levee			GPS Latitude/Longitude	
				Start	End
Item	Animal Control			37.972590 °	37.972590 °
				-121.112938 °	-121.112938 °
DWR ID	DWR_NA0017_15_s _ 2014_122				
Action/Comments					
No rodents visible, but rodent burrows visible; need to backfill and compact or grout burrows.

A rodent hole was found on the waterside of the levee looking downstream.

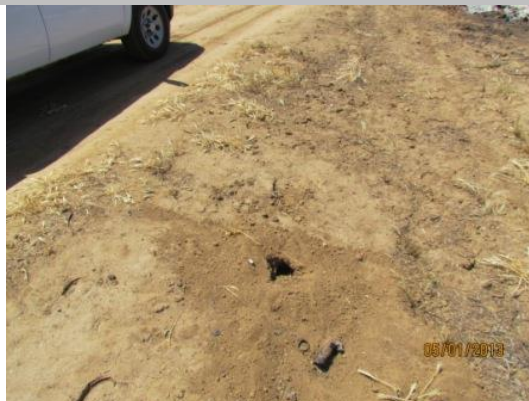
Photo 1 of 1 : SP_2015_NA0017_159_62_20150313_00044.jpg

LM Start	8.32	Rating **	M	Issue No.	62
LM End	8.32	Issue Type +	Ma	Location *	LS
Category	Earthen Levee			GPS Latitude/Longitude	
				Start	End
Item	Animal Control			37.970147 °	37.970147 °
				-121.114849 °	-121.114849 °
DWR ID	DWR_NA0017_15_s _ 2013_62				
Action/Comments					
No rodents visible, but rodent burrows visible; need to backfill and compact or grout burrows.

An animal hole was found on the landside slope of the levee looking downstream.

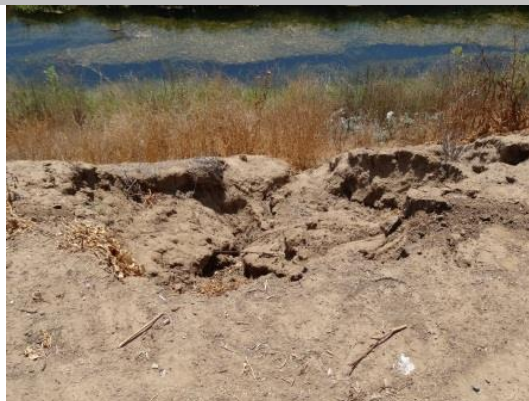
Photo 1 of 1 : SP_2015_NA0017_159_125_20150313_00084.jpg

LM Start	8.43	Rating **	M	Issue No.	125
LM End	8.43	Issue Type +	Ma	Location *	WS
Category	Supplemental			GPS Latitude/Longitude	
				Start	End
Item	DWR Erosion Survey			37.969711 °	37.969711 °
				-121.116739 °	-121.116739 °
DWR ID	DWR_NA0017_15_s _ 2015_125				
Action/Comments					
Inspector Comments: 8/20/2014: No significant change observed. 09/12/2013: The erosion has been caused by runoff. [2014 Site ID:NA0017U15RM14.49]

Looking down at the erosion from the levee crest.

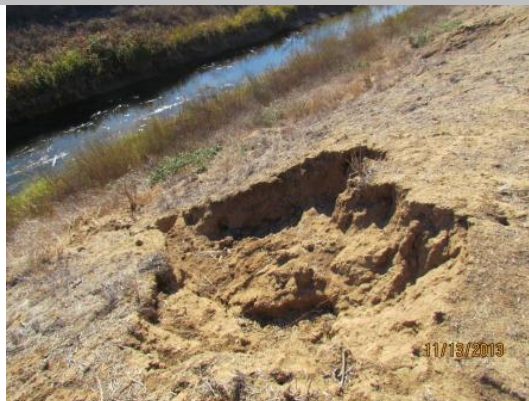
Photo 1 of 3 : SP_2015_NA0017_159_65_20150313_00046.jpg

LM Start	8.43	Rating **	M	Issue No.	65
LM End	8.43	Issue Type +	Ma	Location *	WS
Category	Earthen Levee			GPS Latitude/Longitude	
				Start	End
Item	Slope Stability			37.969748 °	37.969748 °
				-121.116767 °	-121.116767 °
DWR ID	DWR_NA0017_15_s_2013_65				
Action/Comments					
Repair slope instability.

Updated picture of the slope instability on the waterside of the levee looking downstream during fall 2013 inspection.

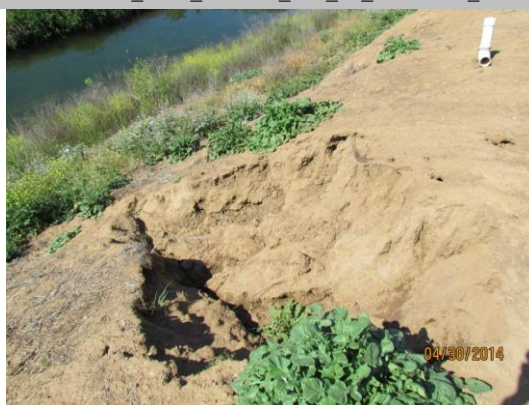
Photo 2 of 3 : SP_2015_NA0017_159_65_20150313_00047.jpg

Updated picture of the slope instability on the waterside of the levee looking downstream during spring 2014 inspection.

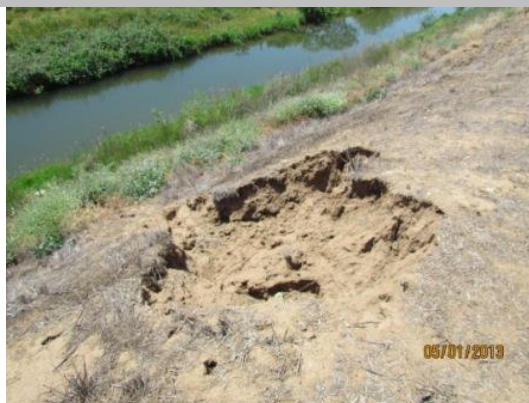
Photo 3 of 3 : SP_2015_NA0017_159_65_20150313_00048.jpg

A slope instability was found on the waterside slope of the levee looking downstream.

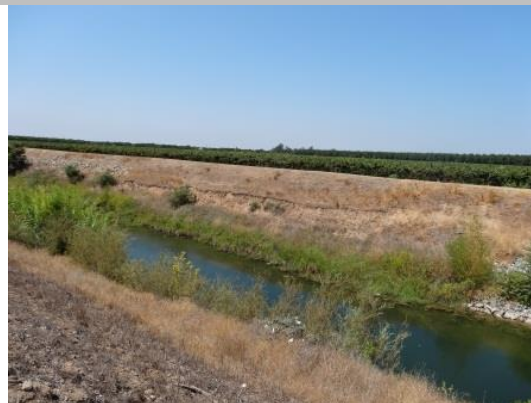
Photo 1 of 1 : SP_2015_NA0017_159_7_20150313_00005.jpg

LM Start	8.82	Rating **	M	Issue No.	7
LM End	8.82	Issue Type +	Ma	Location *	WS
Category	Supplemental			GPS Latitude/Longitude	
				Start	End
Item	DWR Erosion Survey			37.968060 °	37.968060 °
				-121.123299 °	-121.123299 °
DWR ID	DWR_NA0017_15_s_2015_7				
Action/Comments					
Inspector Comments: 8/20/2014: Both ends of the erosion site are protected by riprap. [2014 Site ID:NA0017U15RM13.87]

View of the site from the left river bank.

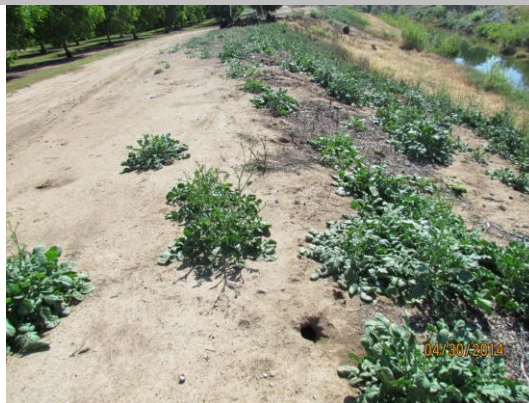
Photo 1 of 1 : SP_2015_NA0017_159_126_20150313_00085.jpg

LM Start	9.83	Rating **	M	Issue No.	126
LM End	9.83	Issue Type +	Ma	Location *	WS
Category	Earthen Levee			GPS Latitude/Longitude	
				Start	End
Item	Animal Control			37.965343 °	37.965343 °
				-121.140761 °	-121.140761 °
DWR ID	DWR_NA0017_15_s_2014_126				
Action/Comments					
No rodents visible, but rodent burrows visible; need to backfill and compact or grout burrows.

View of rodent holes on the waterside of the levee looking upstream.

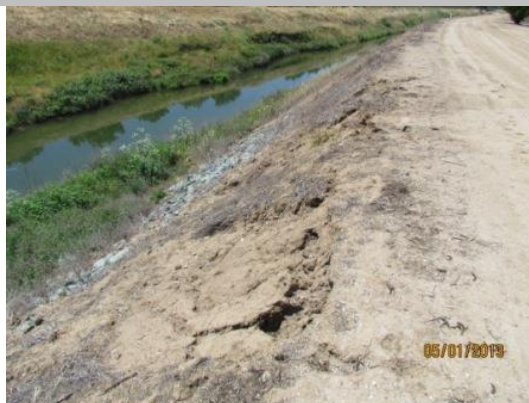
Photo 1 of 1 : SP_2015_NA0017_159_68_20150313_00051.jpg

LM Start	9.90	Rating **	M	Issue No.	68
LM End	9.90	Issue Type +	Ma	Location *	WS
Category	Earthen Levee			GPS Latitude/Longitude	
				Start	End
Item	Slope Stability			37.965165 °	37.965165 °
				-121.141928 °	-121.141928 °
DWR ID	DWR_NA0017_15_s_2013_68				
Action/Comments					
Repair slope instability.

Slope instability was found on the waterside slope of the levee looking downstream.

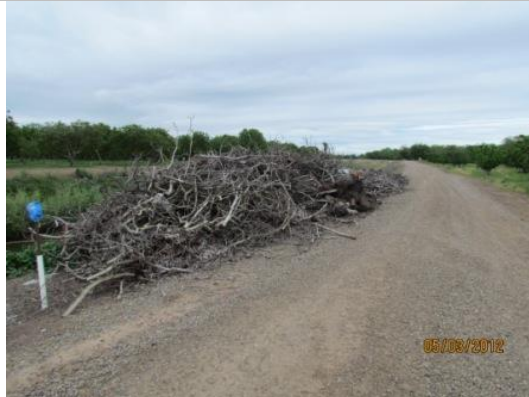
Photo 1 of 2 : SP_2015_NA0017_159_78_20150313_00056.jpg

LM Start	10.40	Rating **	M	Issue No.	78
LM End	10.40	Issue Type +	Ma	Location *	WS
Category	Earthen Levee			GPS Latitude/Longitude	
				Start	End
Item	Encroachments			37.964942 °	37.964942 °
				-121.151073 °	-121.151073 °
DWR ID	DWR_NA0017_15_s_2012_78				
Action/Comments					
Prunings

Prunings were found on the waterside of the levee looking downstream.

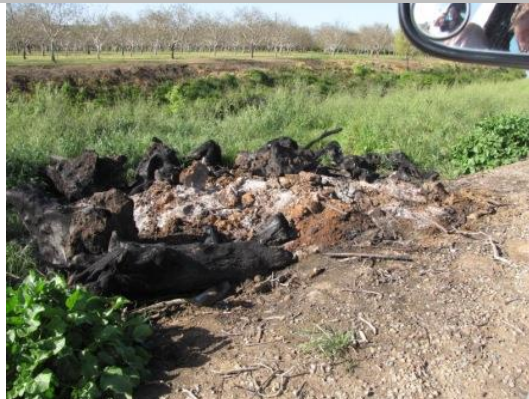
Photo 2 of 2 : SP_2015_NA0017_159_78_20150313_00057.jpg

View of the prunings pile on the waterward slope looking downstream.

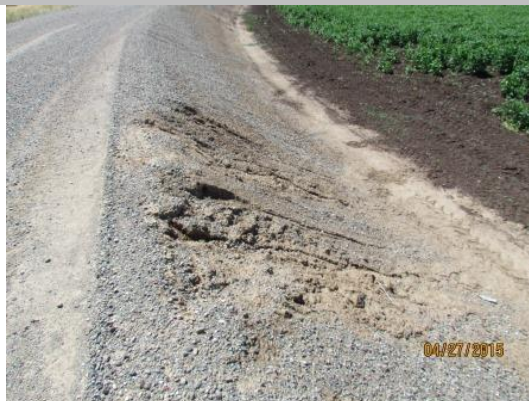
Photo 1 of 1 : SP_2015_NA0017_159_155_20150429_00139.jpg

View of slope instability on the landside of the levee looking upstream.

LM Start	12.30	Rating **	M	Issue No.	155
LM End	12.30	Issue Type +	Ma	Location *	LS
Category	Earthen Levee			GPS Latitude/Longitude	
				Start	End
Item	Slope Stability			37.961410 °	37.961410 °
				-121.184231 °	-121.184231 °
DWR ID	DWR_NA0017_15_s_2015_155				
Action/Comments					
Repair slope instability.

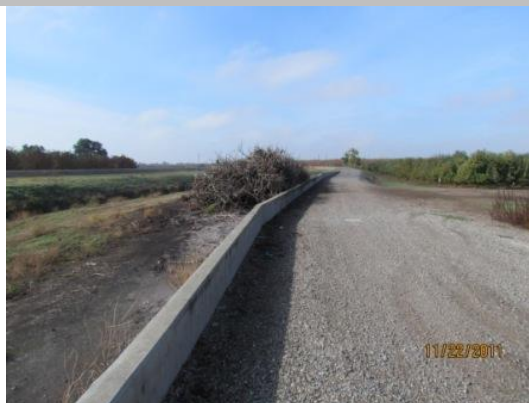
Photo 1 of 1 : SP_2015_NA0017_159_46_20150313_00036.jpg

LM Start	12.57	Rating **	M	Issue No.	46
LM End	12.57	Issue Type +	Ma	Location *	WS
Category	Earthen Levee			GPS Latitude/Longitude	
				Start	End
Item	Encroachments			37.961012 °	37.961012 °
				-121.189067 °	-121.189067 °
DWR ID	DWR_NA0017_15_s_2012_46				
Action/Comments					
Prunings					
Inspector Comments: Burn pile has been burned but new material has been placed.

Prunings were found on the waterside of the levee looking downstream.

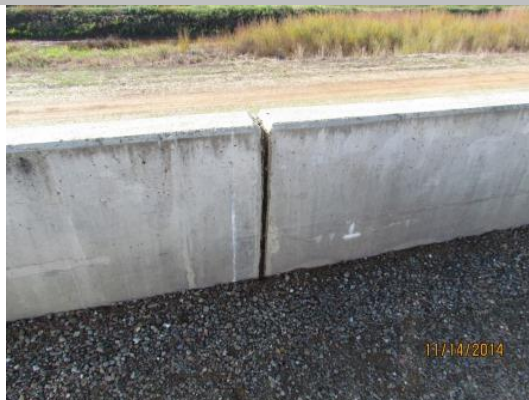
Photo 1 of 1 : SP_2015_NA0017_159_180_20150313_00104.jpg

LM Start	15.04	Rating **	M	Issue No.	180
LM End	15.04	Issue Type +	Ma	Location *	WS
Category	Concrete Floodwalls			GPS Latitude/Longitude	
				Start	End
Item	Monolith Joints			37.973416 °	37.973416 °
				-121.228922 °	-121.228922 °
DWR ID	DWR_NA0017_15_f_2014_180				
Action/Comments

The monolith joint is deteriorating on the waterside shoulder of the levee.

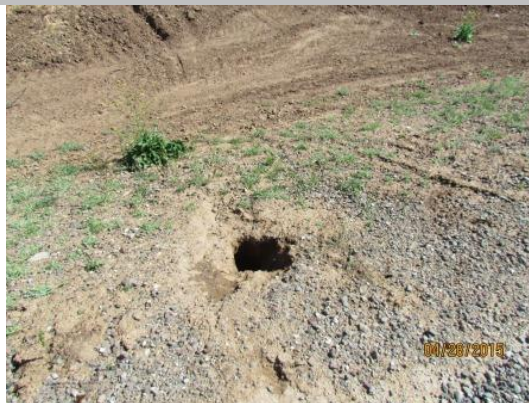
Photo 1 of 2 : SP_2015_NA0017_159_32_20150429_00141.jpg

Updated picture of the rodent hole on the landside of the levee during spring 2015 inspection.

LM Start	15.42	Rating **	M	Issue No.	32
LM End	15.42	Issue Type +	Ma	Location *	LS
Category	Earthen Levee			GPS Latitude/Longitude	
				Start	End
Item	Animal Control			37.975959 °	37.975959 °
				-121.235058 °	-121.235058 °
DWR ID	DWR_NA0017_15_s _ 2014_32				
Action/Comments					
No rodents visible, but rodent burrows visible; need to backfill and compact or grout burrows.

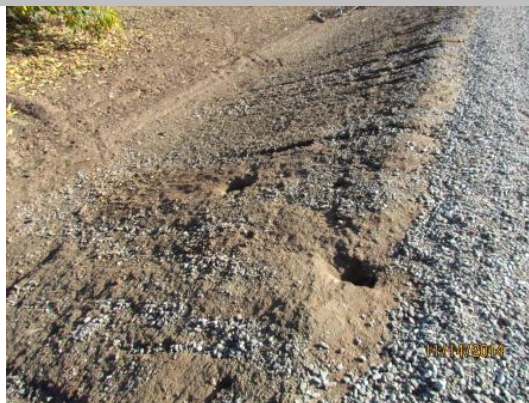
Photo 1 of 2 : SP_2015_NA0017_159_71_20150313_00052.jpg

Updated picture of the animal hole on the landside of the levee looking upstream during fall 2014 inspection.

LM Start	15.43	Rating **	M	Issue No.	71
LM End	15.43	Issue Type +	Ma	Location *	LS
Category	Earthen Levee			GPS Latitude/Longitude	
				Start	End
Item	Animal Control			37.976000 °	37.976000 °
				-121.235156 °	-121.235156 °
DWR ID	DWR_NA0017_15_s _ 2013_71				
Action/Comments					
No rodents visible, but rodent burrows visible; need to backfill and compact or grout burrows.

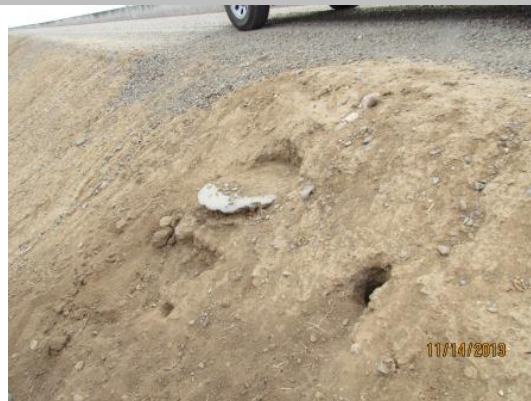
Photo 2 of 2 : SP_2015_NA0017_159_71_20150313_00053.jpg

An animal hole was found on the landside slope of the levee looking upstream.

LM Start	15.43	Rating **	M	Issue No.	71 (cont)
LM End	15.43	Issue Type +	Ma	Location *	LS
Category	Earthen Levee			GPS Latitude/Longitude	
				Start	End
Item	Animal Control			37.976000 °	37.976000 °
				-121.235156 °	-121.235156 °
DWR ID	DWR_NA0017_15_s_2013_71				
Action/Comments					
No rodents visible, but rodent burrows visible; need to backfill and compact or grout burrows.

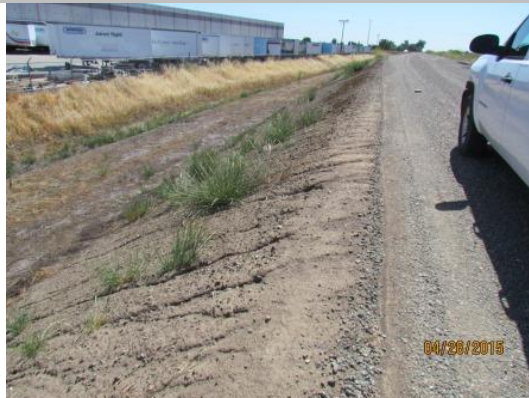
Photo 1 of 1 : SP_2015_NA0017_159_198_20150429_00142.jpg

View of slope instability due to runoff on the landside of the levee looking upstream.

LM Start	16.14	Rating **	M	Issue No.	198
LM End	16.14	Issue Type +	Ma	Location *	LS
Category	Earthen Levee			GPS Latitude/Longitude	
				Start	End
Item	Slope Stability			37.980961 °	37.980961 °
				-121.246553 °	-121.246553 °
DWR ID	DWR_NA0017_15_s_2015_198				
Action/Comments					
Repair slope instability. Inspector Comments: Runoff

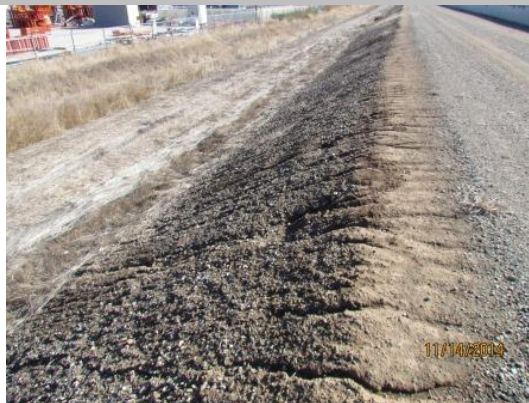
Photo 1 of 1 : SP_2015_NA0017_159_184_20150313_00105.jpg

Erosion caused by surface runoff was found on the landside of the levee looking upstream.

LM Start	16.26	Rating **	M	Issue No.	184
LM End	16.26	Issue Type +	Ma	Location *	LS
Category	Earthen Levee			GPS Latitude/Longitude	
				Start	End
Item	Erosion / Bank Caving			37.981800 °	37.981800 °
				-121.248545 °	-121.248545 °
DWR ID	DWR_NA0017_15_f_2014_184				
Action/Comments					
Schedule repair of erosion site prior to the next inspection. Inspector Comments: Surface runoff.

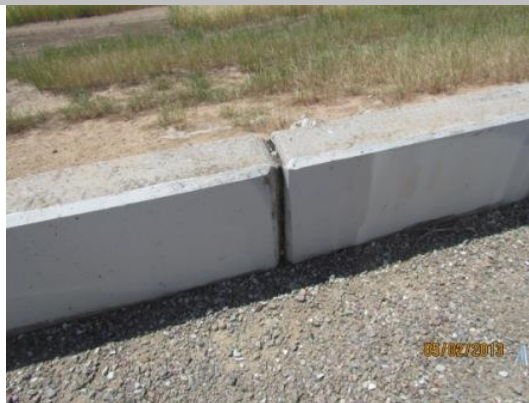
Photo 1 of 1 : SP_2015_NA0017_159_93_20150313_00064.jpg

LM Start	16.56	Rating **	M	Issue No.	93
LM End	16.56	Issue Type +	Ma	Location *	WS
Category	Concrete Floodwalls			GPS Latitude/Longitude	
				Start	End
Item	Monolith Joints			37.983744 °	37.983744 °
				-121.253211 °	-121.253211 °
DWR ID	DWR_NA0017_15_s_2013_93				
Action/Comments

The monolith joint material is deteriorating at the waterside shoulder of the levee looking downstream.

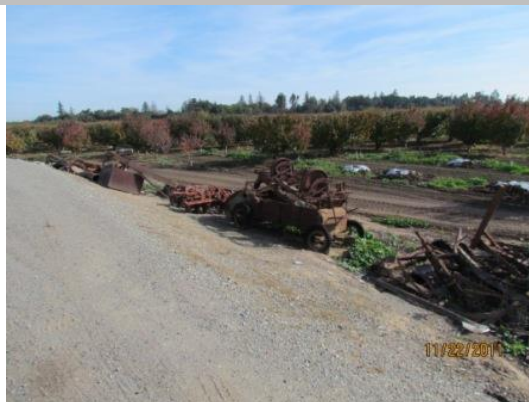
Photo 1 of 1 : SP_2015_NA0017_159_567_20150313_00109.jpg

LM Start	18.30	Rating **	M	Issue No.	567
LM End	18.30	Issue Type +	Ma	Location *	LS
Category	Earthen Levee			GPS Latitude/Longitude	
				Start	End
Item	Encroachments			37.994859 °	37.994859 °
				-121.275862 °	-121.275862 °
DWR ID	DWR_NA0017_15_s _ 2012_567				
Action/Comments					
Equipment

Equipment was found on the landside of the levee looking downstream.
